Applying Infrared Imaging Techniques to Marine Surveying

*John (JACK) N. Allinson
J.N. Allinson Associates, Inc.*

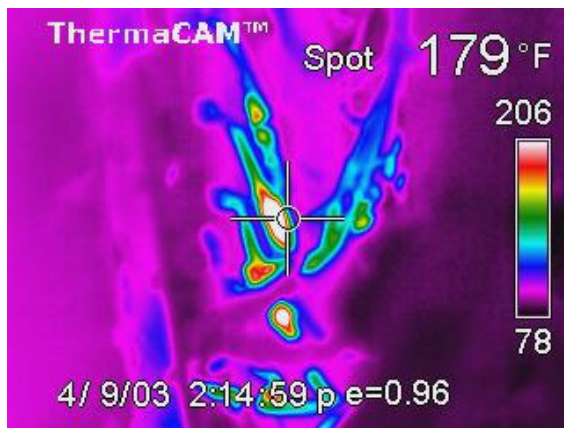
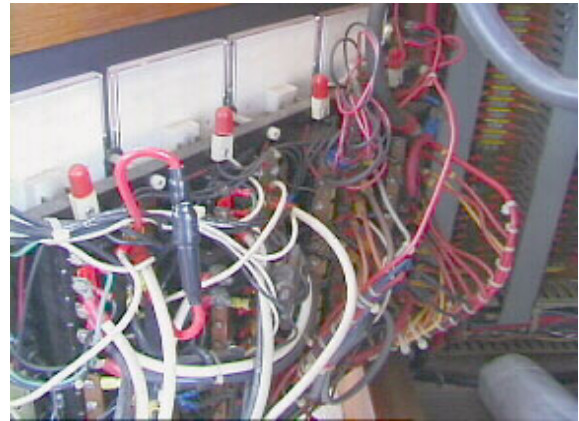
Figure 1. This is the back of an electric distribution panel in a 40-foot boat. Visual inspection shows that the wires are intact, wire insulation and terminals were free of burn or scorch marks. Infrared view shows that one of the wires in the bundle of wires is much hotter than the others. The heat and resistance in this wire caused its magnetic circuit breaker to trip intermittently.

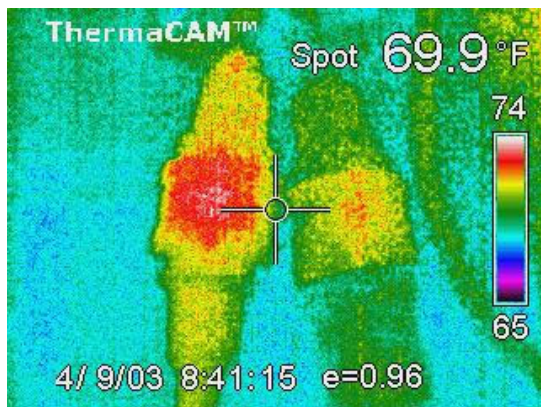
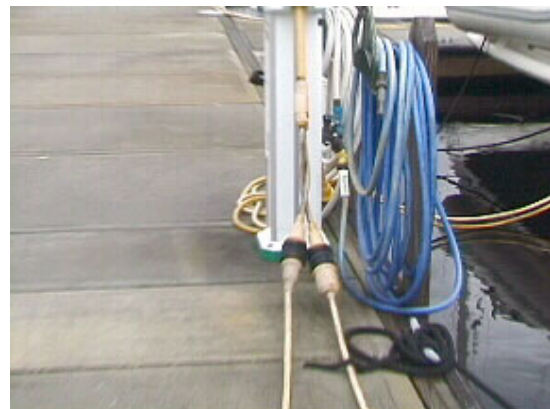
Figure 2. This is a power pedestal on a dock that supplies electric power (shore power) to a boat. A single 50 amp 220vAC shore power cord (light yellow) splits into two (2) 30 amp 110 VAC feeds. This item is known as a “Y adapter” and commonly used for boats that have two (2) 30 amp 120 VAC inlets. There is electrical resistance is building up on the left leg of the “Y adapter” and it should be scheduled to be replaced.

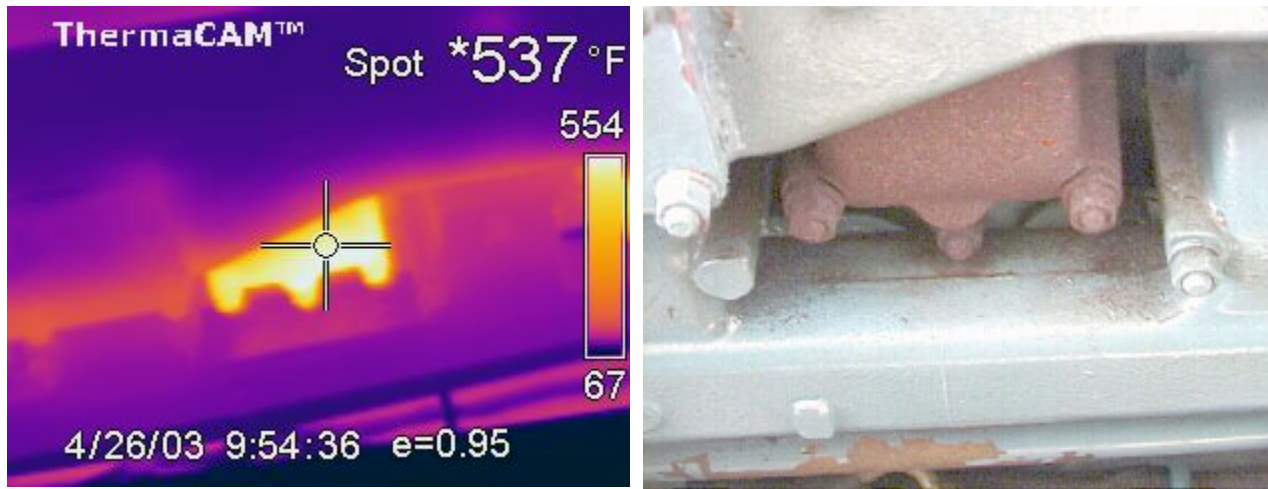
Figure 3. Views of a portion of an exhaust manifold for a 160 hp 6 cylinder turbocharged diesel engine. During the sea trial, the engine overheated. A thermal image of one of the exhaust ports on the manifold showed excessive temperature. Buyer advised to have a marine mechanic examine the turbocharger system.

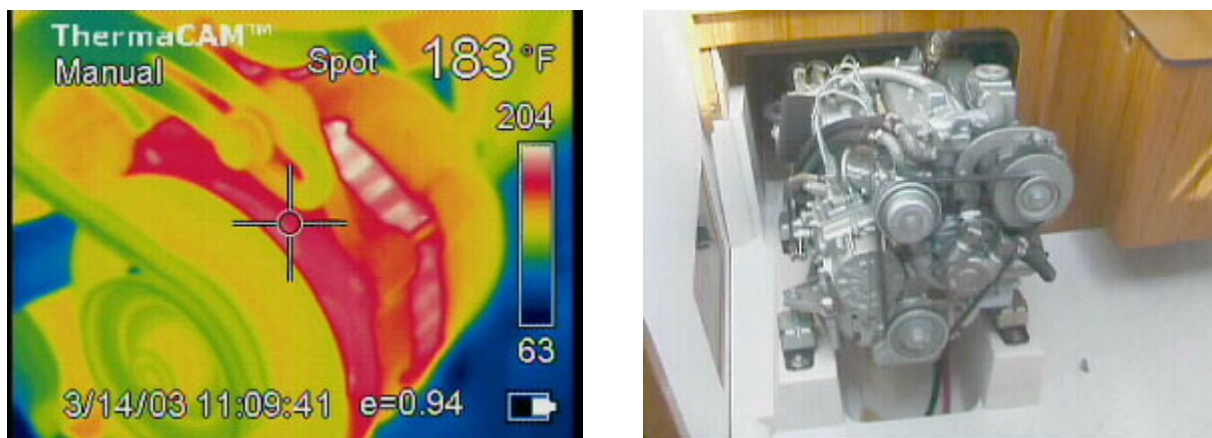
Figure 4. Views of a 3-cylinder naturally aspirating diesel engine. Visual photograph (right) shows the engine with a factory installed low amperage output 12VDC alternator. Owner replaced original “wet cell” battery bank to one with a larger capacity. The new battery bank was much too large to be effectively charged by the factory installed alternator. There were no visual signs that the alternator was being overworked, however the battery bank would never get fully charged and batteries suffered from sulfation. Infrared showed windings in alternator were hotter than expected. This visual evidence coupled with measuring low input voltage at the battery terminals solidified the recommendation why the buyer should upgrade to a higher amperage output alternator.

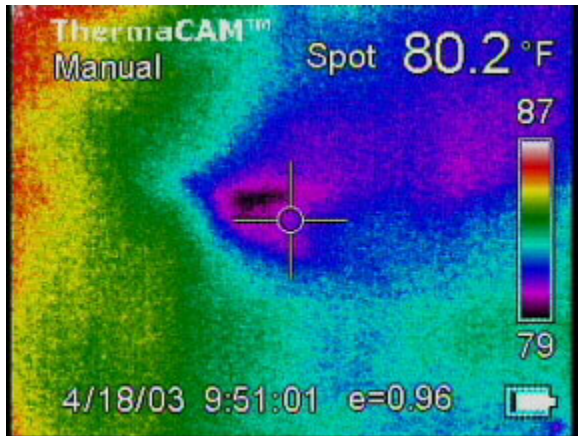
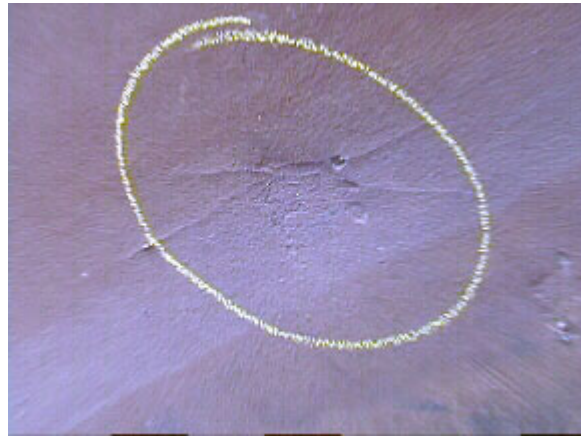
Figure 5. The area circled in yellow shows an unusual indentation in the hull of a boat constructed with FRP. Area visually appears dry. Infrared image shows cooler temperature, revealing moisture intrusion in this portion of the hull.

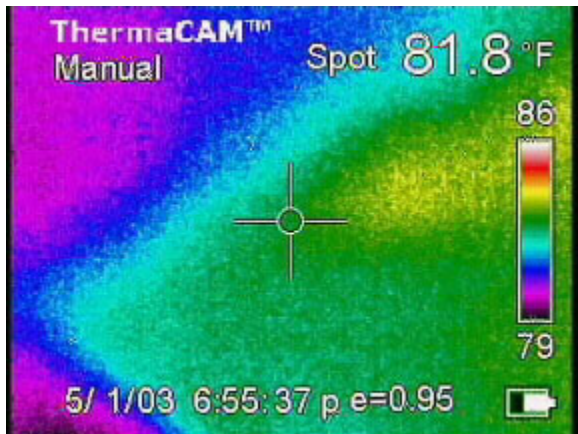
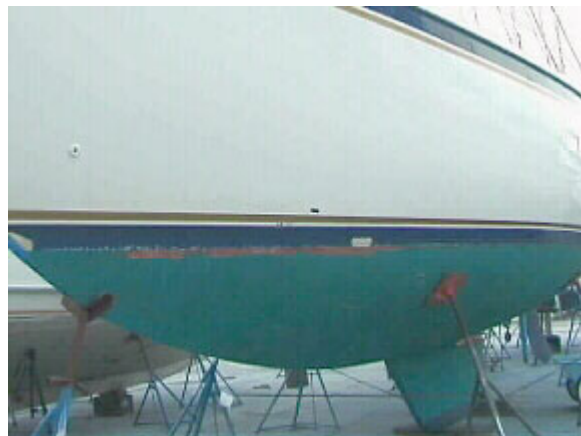
Figure 6. This is the side of a sailboat constructed with FRP. The sailboat sustained impact damage and there was a faint visual sign of delamination. The infrared image shows warmer temperatures, revealing the extent and pattern of delamination in the FRP.

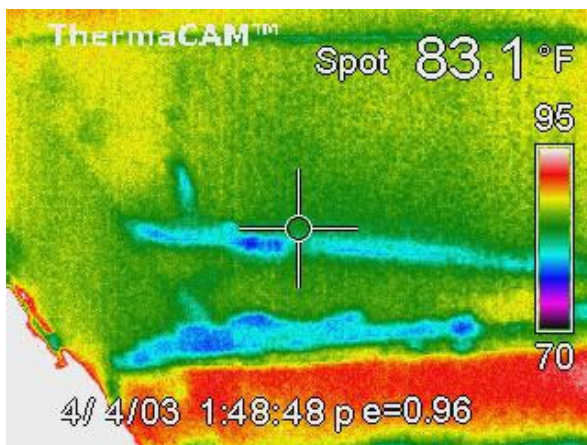
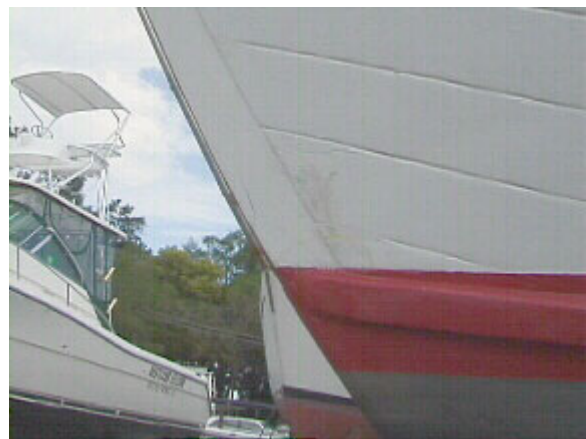
Figure 7. Views of the bow of a boat hull constructed of wooden planks. Routine maintenance involves caulking the seams between the wooden planks to prevent moisture intrusion. The infrared image confirms that caulking is needed as it shows cooler areas where moisture has entered into seams.

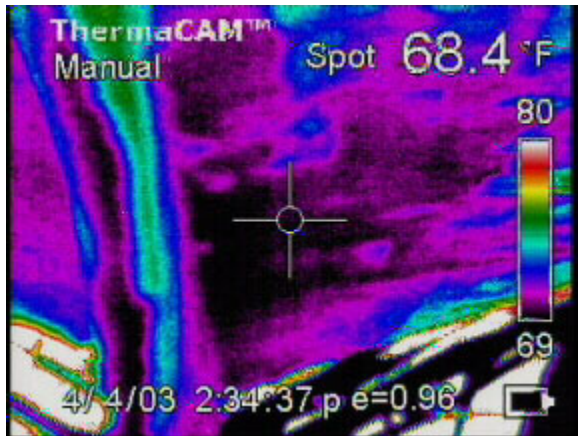
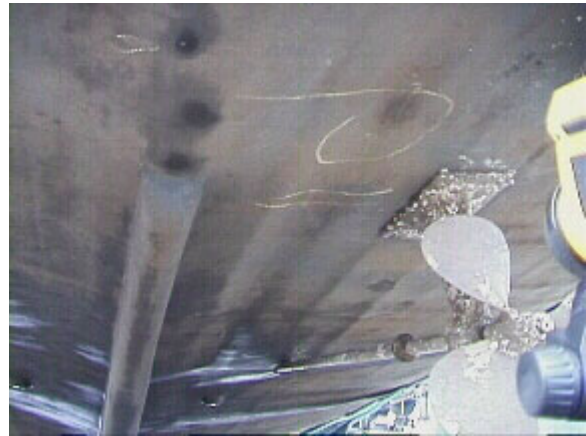
Figure 8. A common practice to extend the life of the bottom of a wooden boat is to sheath it in FRP. It is used to reduce maintenance and prevent marine organisms (e.g., Terado worms) from boring into the wood. Sometimes the physical bond between the wood and FRP breaks down, and water gets trapped in the interstitial space. The wood continues to decay and the FRP disbonds from the wood. Coolness in the infrared image shows the extent of water entrapment and disbonding that can be heard when sounding the hull with a percussion hammer.

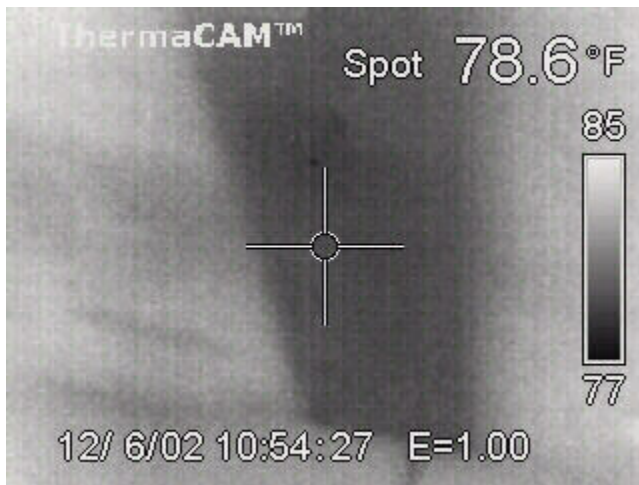
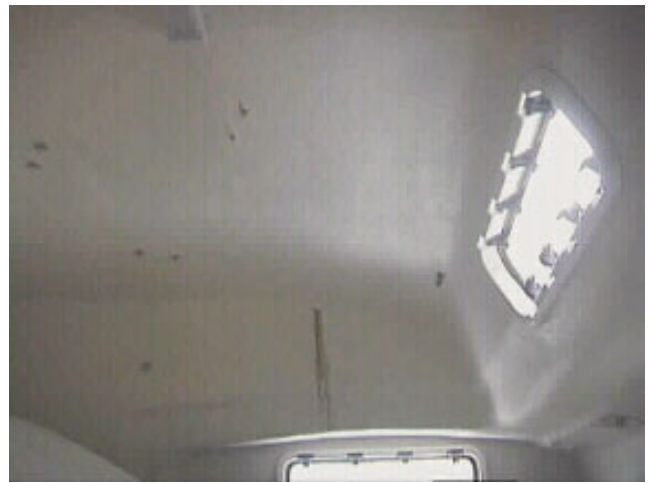
Figure 9. This is the interior ceiling of a FRP constructed catamaran sailboat. Brown fluid observed running out down the ceiling wall visually shows there is a problem with water intrusion. The ceiling is a sandwich construction composite of an outer skin of FRP, an intermediate core of wood, and an inner skin of FRP. The black and white pallet infrared image (left) shows the extent of moisture intrusion.

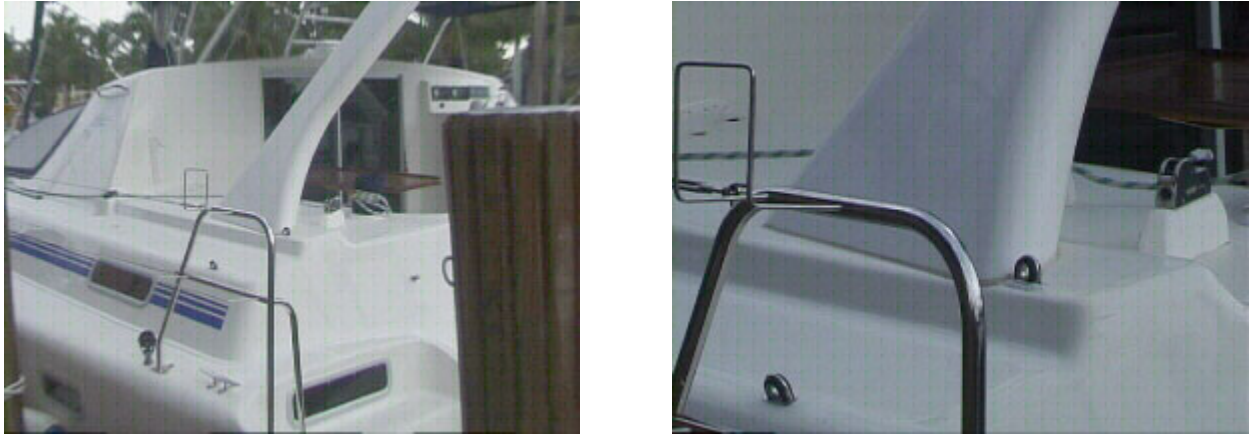
Figure 10. On deck photos of the sailing catamaran shows the exterior side corresponding to the interior ceiling. Note the raised deck in the FRP construction. It is common practice to use a composite construction to reduce the weight of the boat. In this case the composite is FRP/wood/FRP. If the raised deck area were constructed with a solid FRP laminate, it would be much heavier and cost more to construct. A lighter boat sails faster than a heavier boat.
